Executive Summary

This Tiger Grant Application is being jointly requested by the New Hampshire Department of Transportation (NHDOT) and the Vermont Agency of Transportation (VTrans) for the superstructure replacement of the Lebanon-Hartford Interstate 89 bridges over the Connecticut River. This Benefit Cost Analysis (BCA) was completed in accordance with the 2015 Benefit-Cost Analysis Guidance for Tiger Grant Applications and the Tiger Grant BCA Resource Guide. This project will rehabilitate two Structurally Deficient Bridges, improve the geometry and operations of the existing Interstate ramps in close proximity to the bridges, improve the non-standard roadway cross section geometry of the existing structures, improve stormwater runoff treatment, improve access to both the Exit 20 Lebanon NH area and Interstate 91 in Hartford VT, and reduce the crash potential within the area.

Interstate 89 over the Connecticut River

Bridge Rehabilitation Study Report

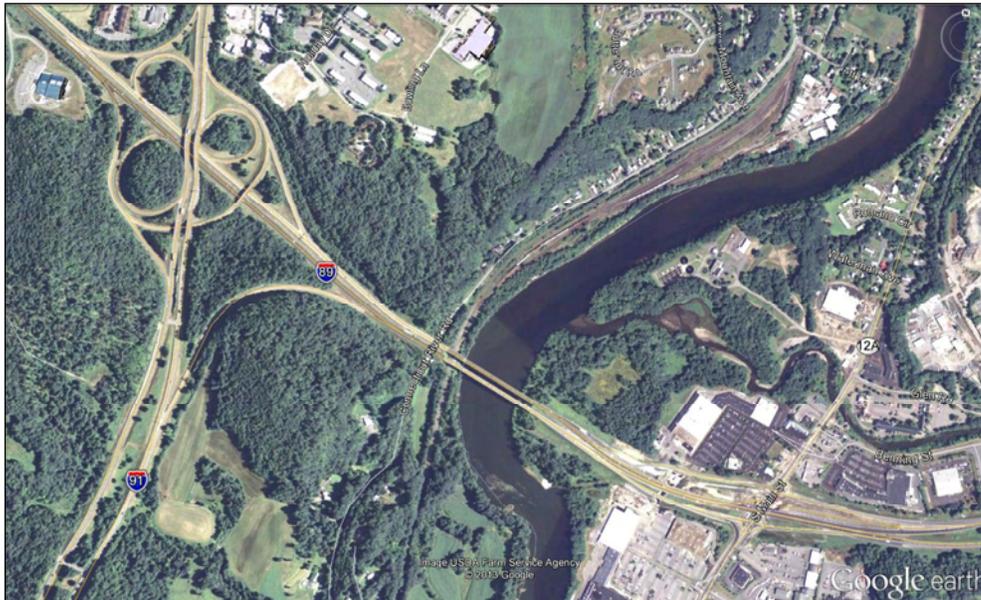
Figure 1. Project Study Area

The New Hampshire Department of Transportation (NHDOT) is planning to rehabilitate the I-89 bridges over the Connecticut River on the New Hampshire/Vermont state line (bridge numbers 044/104 and 044/103). The Connecticut River bridges are located along I-89 between two interchanges approximately one mile apart. On the west side in Hartford, Vermont is the I-91 system interchange and on the east side, in Lebanon, New Hampshire, is the NH-12A (Exit 20) service interchange. Figure 1 is an aerial photo of the project study area.

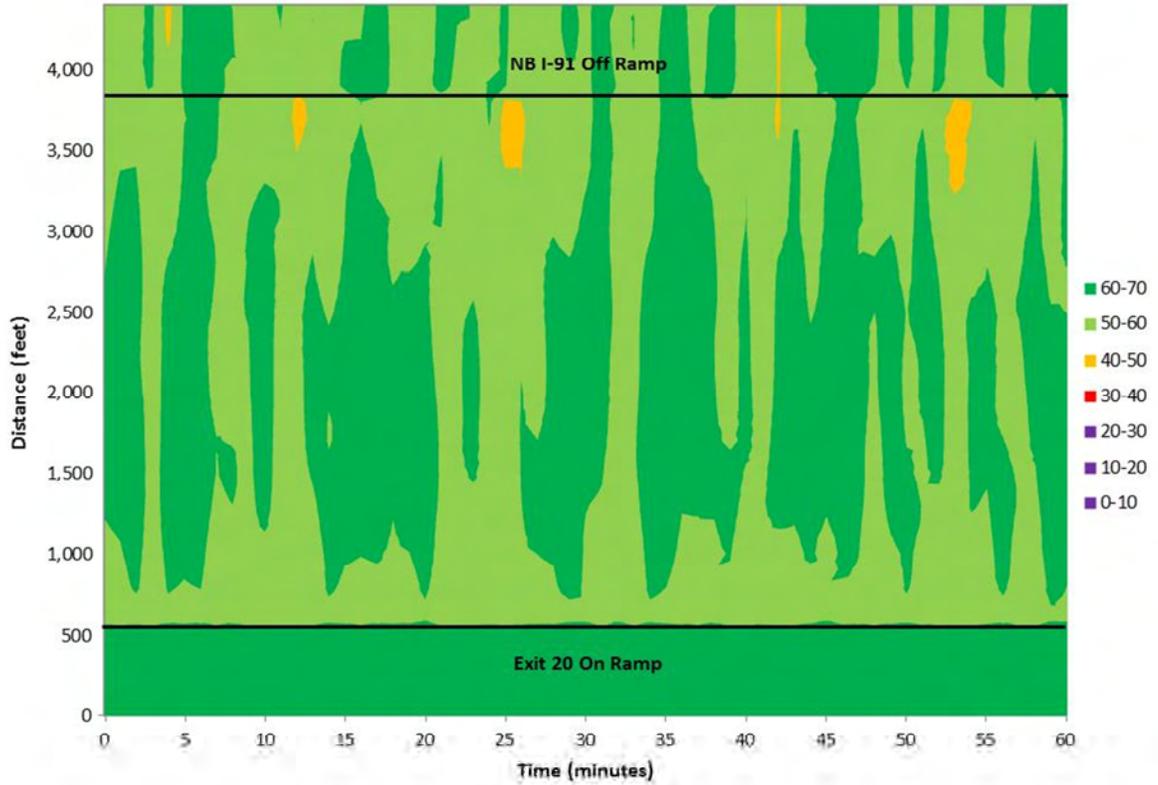
Figure 8. Existing Conditions PM Northbound Speed Details

Figure 8 shows the same information for the northbound direction, which is much more turbulent than the southbound direction. This is due to the positive grades of 2 to 5% along these segments and the affect that they have on traffic, particularly heavy vehicles. However, one can see that the turbulence increases at the merge and diverge points where lane changing operations are occurring. The effect is noticeably pronounced at the northbound I-91 off ramp where there is a 5% grade and lane changing operations for vehicles desiring to take the off ramp to I-91.

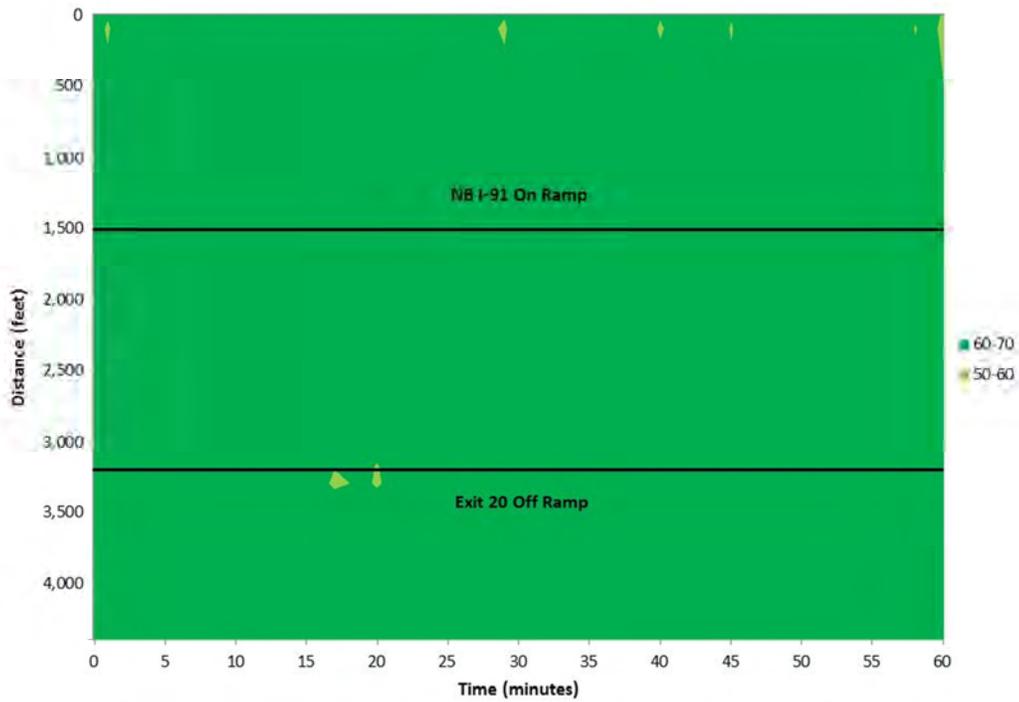
Figure 13. 2039 AM Build Conditions Southbound Speed Details

Figure 13 shows the same information for the 2039 Build scenario and clearly illustrates that adding a southbound auxiliary lane will eliminate virtually all of the areas of speeds below 60 mph.

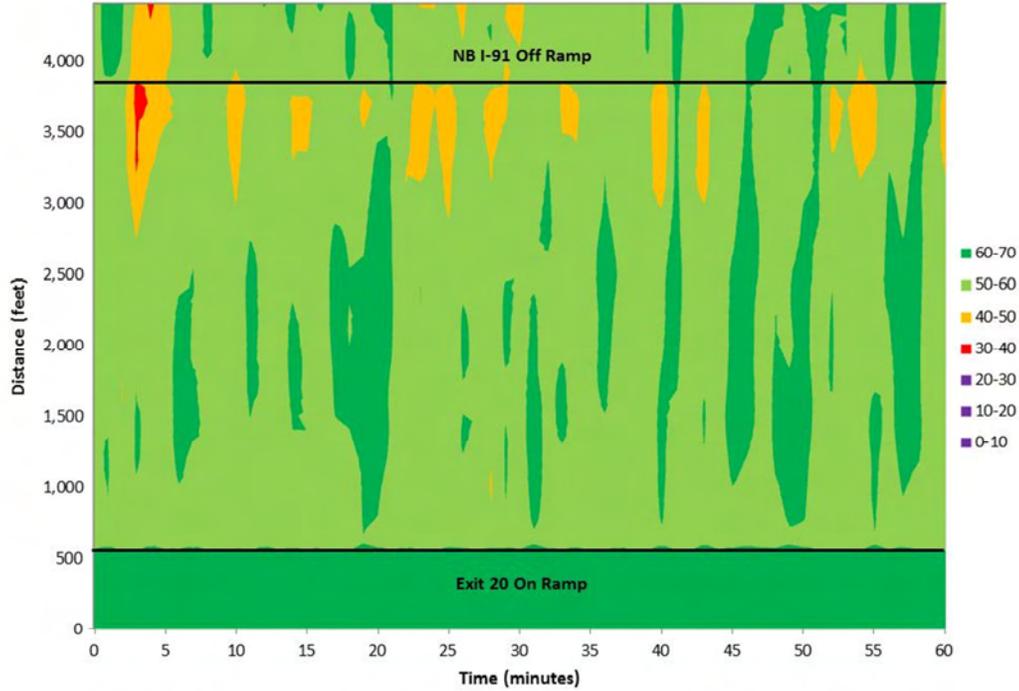
Figure 14. 2039 PM No Build Conditions Northbound Speed Details

Figure 14 shows 2039 PM peak hour detailed speed information for the northbound direction, which, as seen in the existing conditions analysis, is much more turbulent than the southbound direction, again due to the positive grades. By 2039 nearly the entire section between ramps can be expected to operate at speeds less than 50 mph with substantial time at speeds less than 50 mph at the northbound I-91 off-ramp.

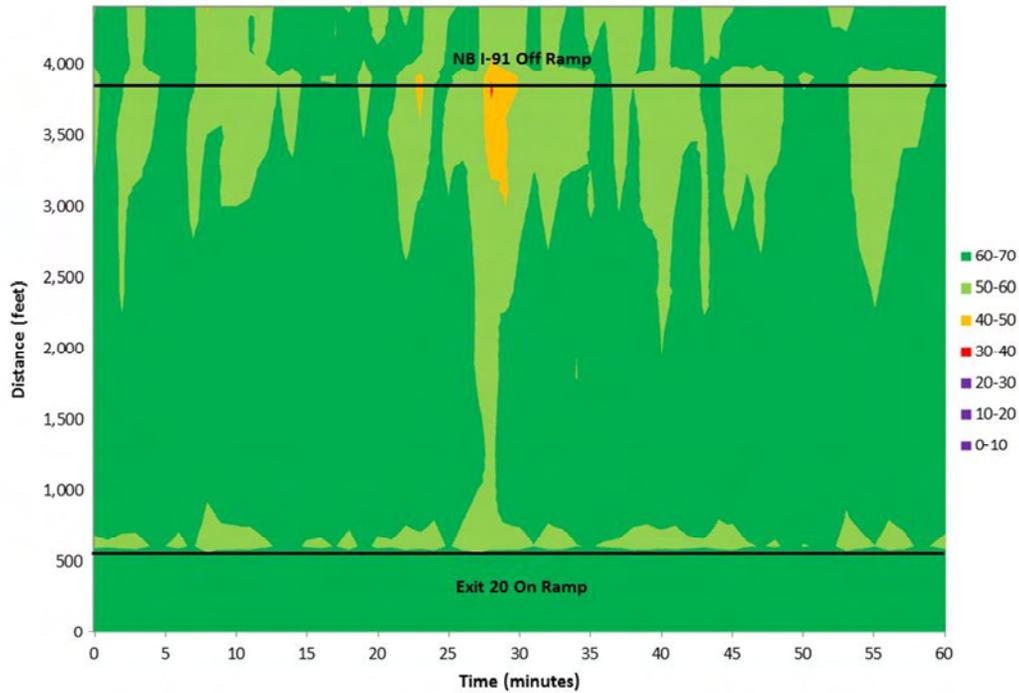
Figure 15. 2039 PM Build Conditions Northbound Speed Details

Figure 15 shows that the 2039 PM Build scenario dramatically improves the average vehicle speeds in the northbound direction, although not to the same level as previously shown for the southbound direction. Most of the section would operate at speeds over 60 mph, but there would still be occasional pockets of lower speeds.

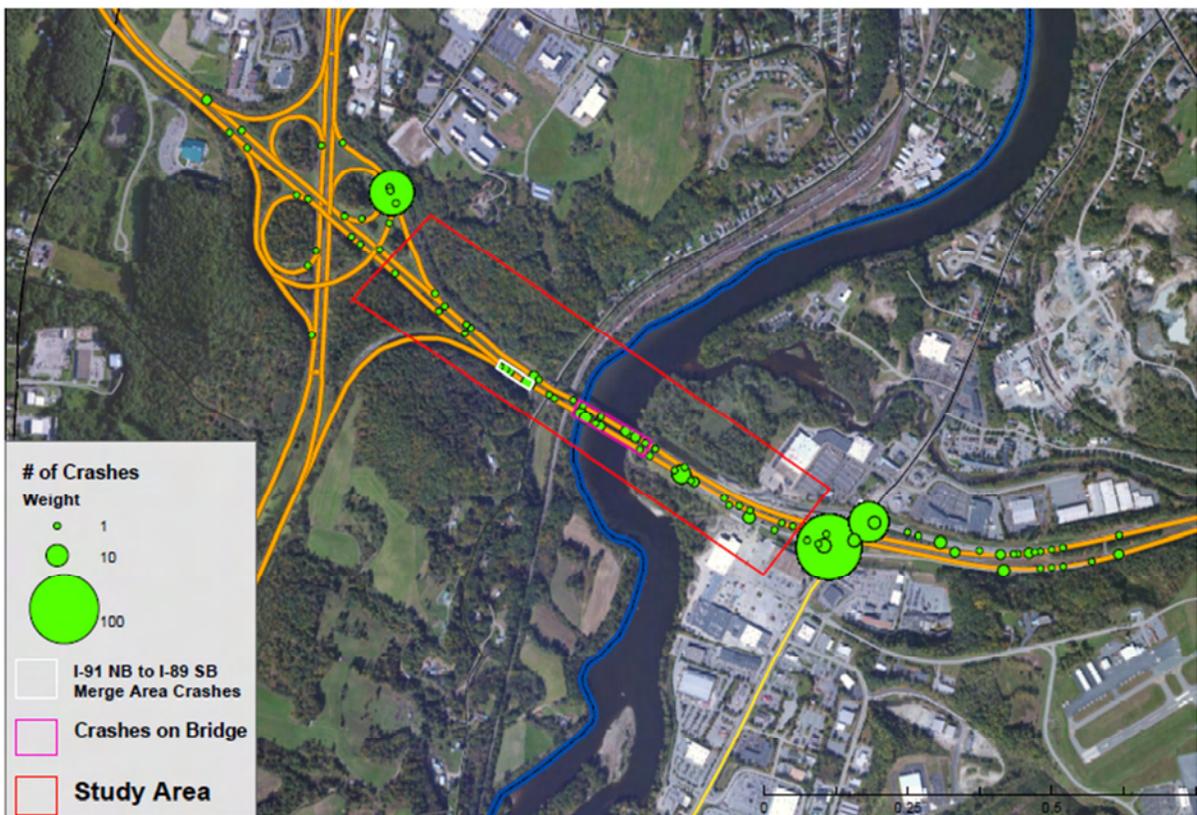
Figure 17. Study Area Crash Locations

Five year crash histories for the study area on and around the Connecticut River bridges were collected from NHDOT and VTrans. The total number of crashes based on both NHDOT and VTrans data that occurred in the five year period between 2007 and 2011 is shown in Figure 17. There are several locations that jump out as high crash locations, although they are all outside of the study area defined by the red rectangle. The highest concentrations of crashes (~120) occur at the Exit 20 ramp terminals, which isn't too surprising given that intersections typically have the highest crash rates largely due to all of the conflicting turning movements made there. The other location that stands out is at the merge of the southbound and northbound I-89 ramps to northbound I-91, which had 41 crashes during this time period.

Within the study area (ie. red rectangle shown in the figure above) there were a total of 65 reported crashes with 18 injuries and no fatalities in the period between 2007 and 2011. As illustrated in Figure 18, the peak crash period occurs between 10am and 1pm, with 21 (32%) accidents occurring in this span. Nearly half (48%) of all crashes occur between the hours of 7:00 am and 1:00 pm.

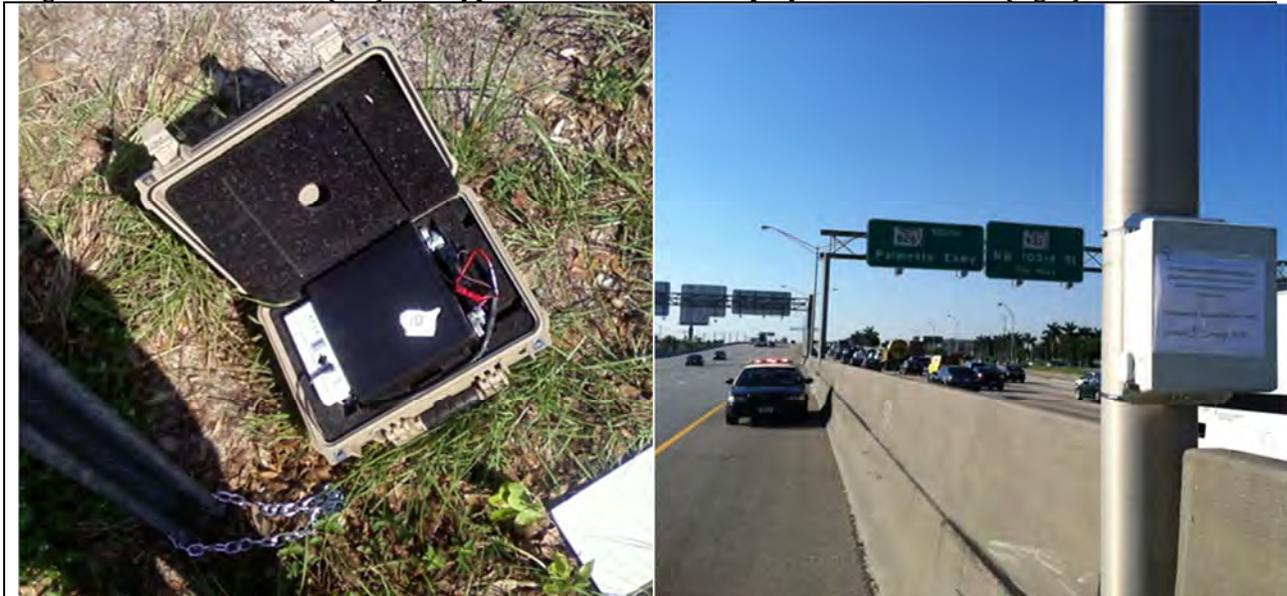
Figure 1: BlueFAX Device (left) and Typical Post-Mounted Deployment on SR-826 (right)

When a Bluetooth-enabled device passes by a BlueFAX sensor, the unique MAC ID of the device and the date and time are captured and stored in the on-board computer. As vehicles with Bluetooth-enabled devices travel through the corridor, they will pass other BlueFAX sensors, where the MAC ID and timestamp will be rec-

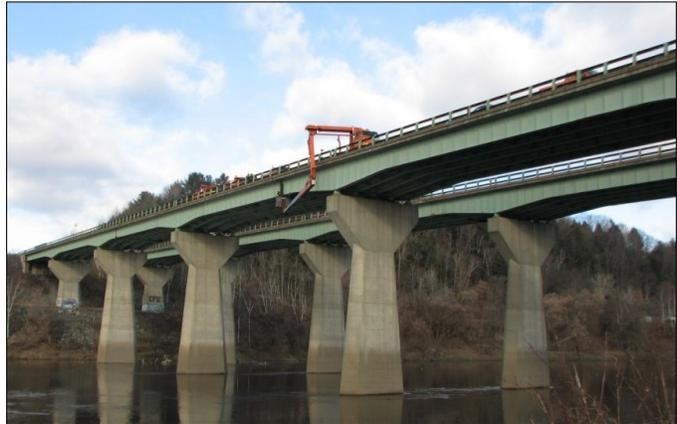
Figure BR1: Westerly Elevation View of Bridges

The I-89 bridges span the Connecticut River and New England Central Railroad (NECRR) between the city of Lebanon, New Hampshire and the town of Hartford, Vermont. The NB and SB barrels each consist of two travel lanes, with direction of travel carried by separate, but identical, bridge structures. Bridge No. 044/103 carries I-89 SB traffic, while Bridge No. 044/104 carries I-89 NB traffic.

The six-span, 840-foot sister bridges were constructed in 1966 and consist of non-composite, haunched steel plate girders founded on cantilever abutments and hammerhead piers. The bridges are inspected and maintained by the NHDOT through a mutual agreement with the Vermont Agency of Transportation (VTrans).

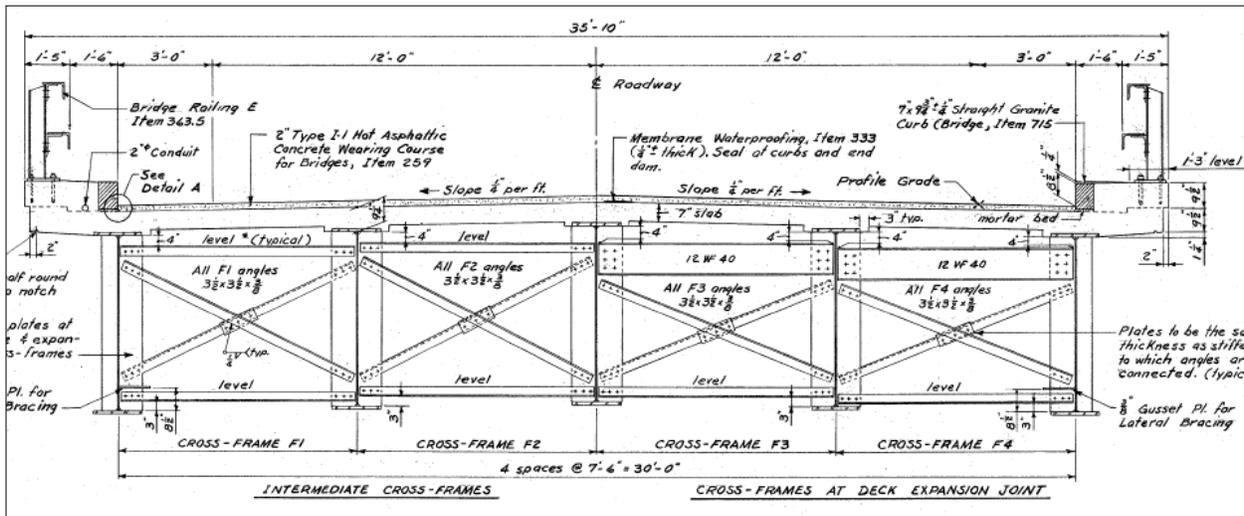
Figure BR3: Existing Bridge Section

The bridges are comprised of five non-composite welded steel (A36) plate girders supporting a 7-inch reinforced concrete deck protected by membrane with a bituminous concrete wearing surface. The six-span configuration consists of two 120'-0" end spans and four 150'-0" interior spans on a three percent tangent profile grade aligned on a ten degree skew. The typical section for each bridge (presented in Figure BR3) measures 35'-10" wide from the outside edge of deck and consists of symmetrically placed 3'-0" shoulders, two 12'-0" travel lanes, and reinforced concrete brush curbs measuring 2'-11" wide each. Per the original design plans, the constant clear distance between the adjacent NB and SB decks is 38'-2".

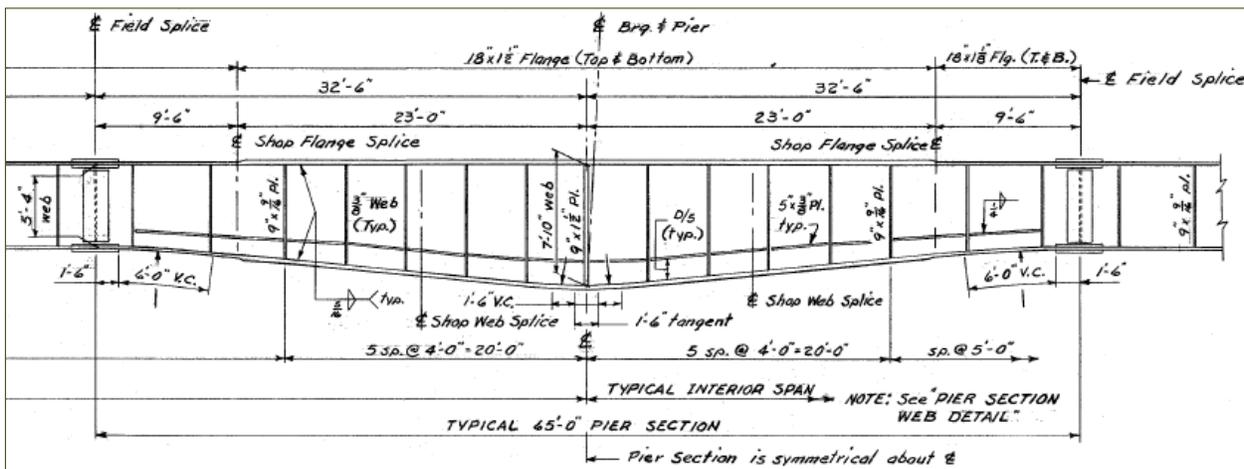
Figure BR4: Typical Girder Detailing at Intermediate Piers

The girder web depth is haunched at each pier (Figure BR4). Vertical web stiffeners are provided along the entire bridge length, and longitudinal web stiffeners are provided at approximately 1/5 of the clear web depth from the bottom flange within the tapered pier sections. Reference Appendix A, Existing Bridge Plans, for additional information.

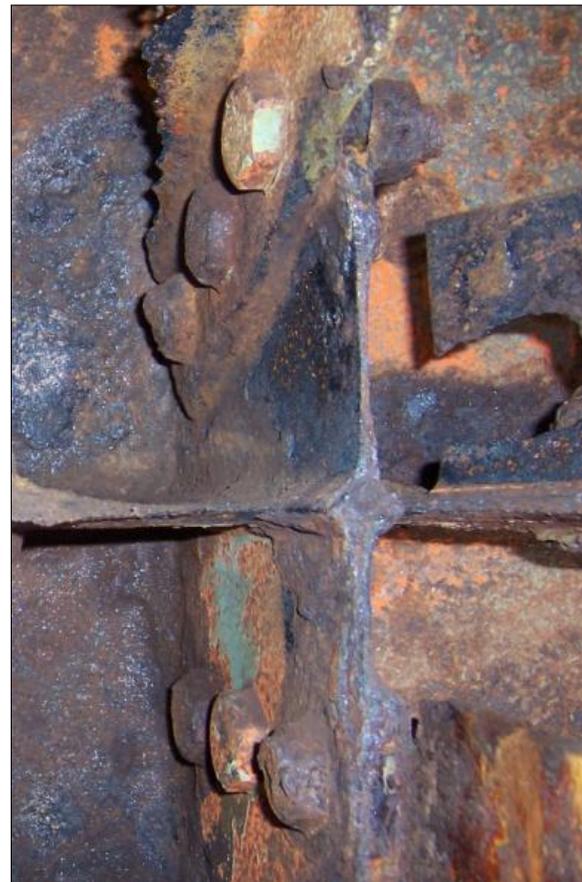
Figure BR6: Knife-Edge. Heavy Section Loss at Stiffener & Gusset Plate

The condition rating of the deck and superstructure is Fair to Poor for both the northbound and southbound structures. The Northbound October 2013 and the Southbound January 2014 bridge rating reports are provided in Appendix B. Specific details regarding the condition of each superstructure are taken from the NHDOT bridge inspection reports and are outlined below:

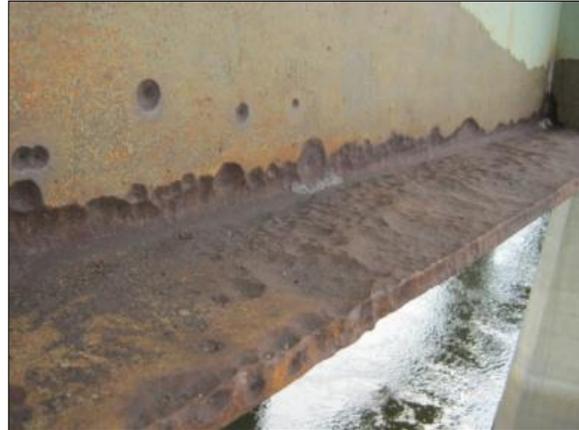
Figure BR7: Bottom Flange Pitting

☼ The deck exhibits moderate concrete delamination at multiple underside locations, with light leaking at the relief joints in Spans 3 and 4 where they pass through the brush curbs. Span 5 exhibits a cracked and depressed area of pavement near the roadway centerline.

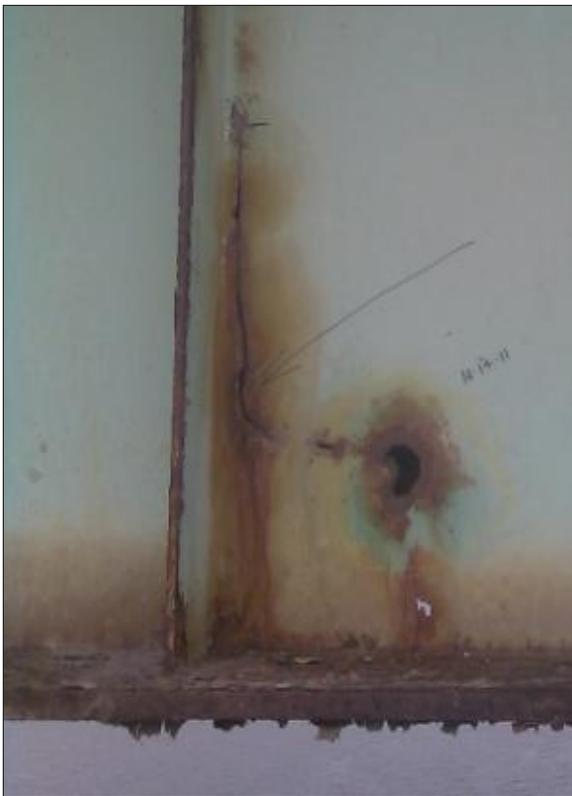
Figure BR8: Hole and Crack in Web at Transverse Stiffener

☼ Isolated web perforations have been noted in the exterior girders, concentrated primarily near the welded gusset plate attachments for lateral bracing. There is an approximate 1 inch hole in the web of Exterior Girder #1 in Span 3, and another location exists in Span 5 where the web is nearly perforated. Section loss of up to 1/4" has been measured along the middle of the exterior girder flanges near the web in this area as well.

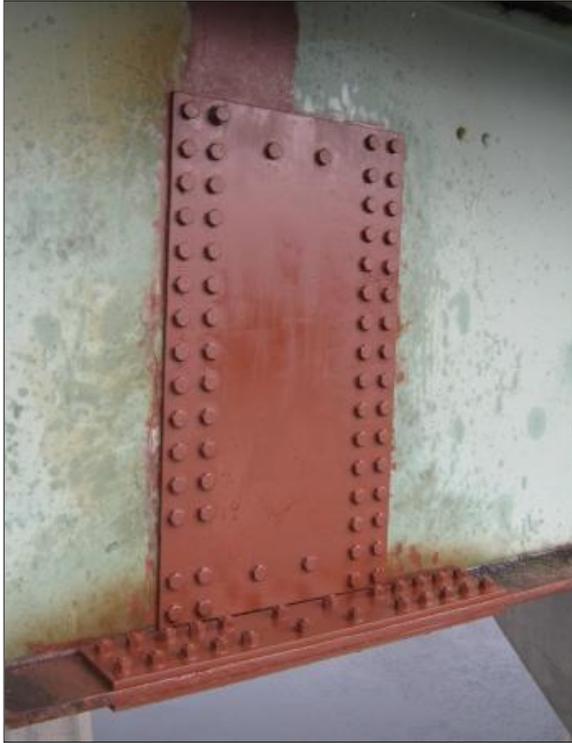
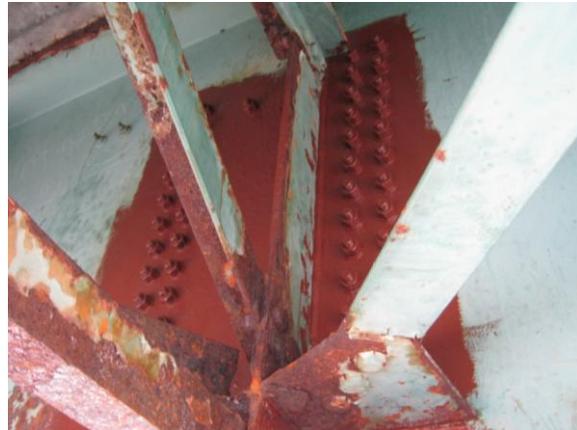
Figure BR9: Web Crack Bolted Plate Repair by NHDOT BBM (outside face)

☼ In December of 2011, the NHDOT repaired a large crack in the westerly exterior girder in Span 4. The crack had progressed approximately 15 inches along the toe of the weld between a vertical stiffener and the web and appeared to have initiated at a nearby hole in the girder web caused by corrosion at the leaking joint (Figure BR8). The repair consisted of removing the stiffener, drilling holes to arrest the crack, and bolting steel splice plates to the web and bottom flange of the girder. The completed repair is presented in Figure BR9.

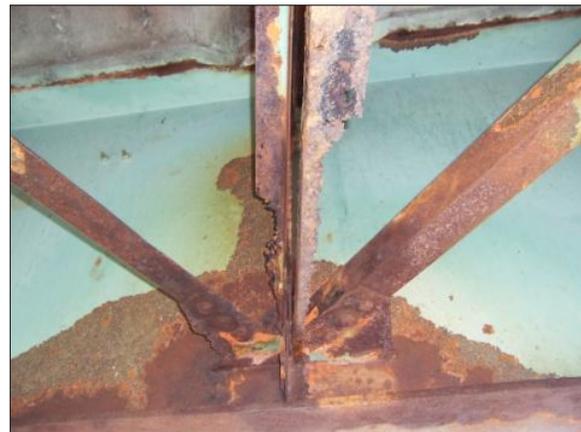
Figure BR11: Heavy Section Loss Under Deck Relief Joint

- ☀ The concrete deck exhibits cracks, isolated light efflorescence, and water staining from leakage through the deck. Leaking is evident at the deck relief joints. Moderate to heavy delamination of the concrete has been observed throughout. Several previously patched areas in the deck are deteriorating as they lose integrity.
- ☀ Minor to light rust on the girders is evident throughout. Paint system failure characterized by cracking and flaking.
- ☀ Heavy corrosion has been observed under the deck relief joints, and on the exterior girders in the north span (Figure BR11).
- ☀ The lateral wind bracing and its gusset plate attachment located below the deck relief joint in span 3 exhibit heavy section loss from joint leakage.

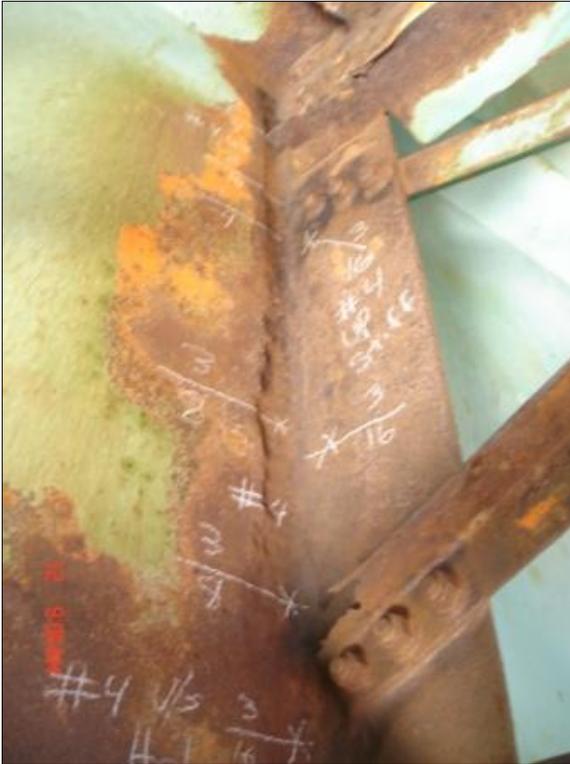
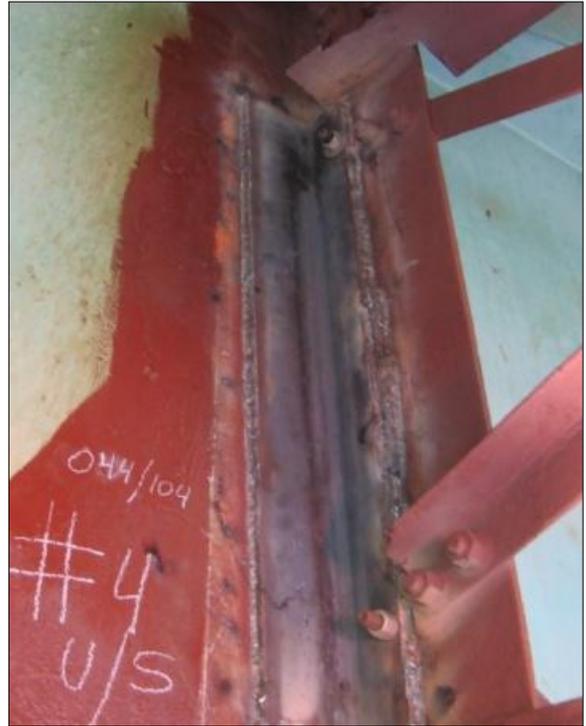
Figure BR12: Heavy Pitting on Web at Transverse Stiffener

- ☼ NHDOT BBM repaired severe pitting and section loss on the web of interior girder #4 in July of 2012. The repair consisted of a steel angle welded on at the intersection of a transverse stiffener and the web. Refer to Figures BR12 and BR13.

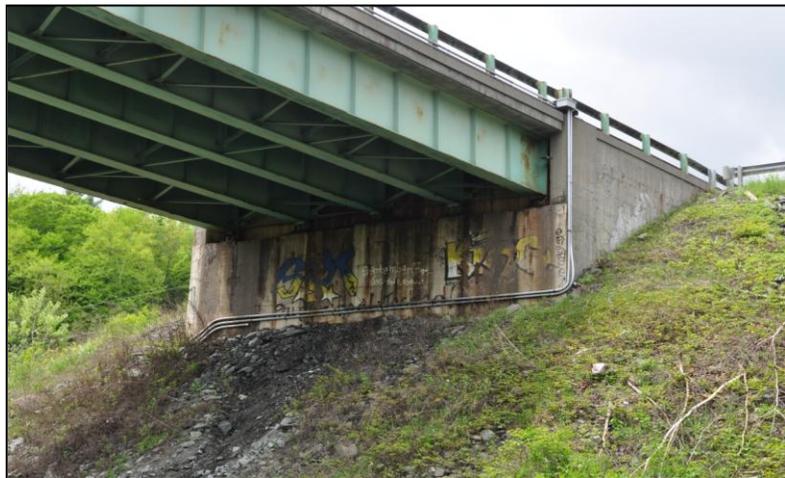
Figure BR14: North abutment on SB Bridge

The substructures generally exhibit relatively minor deterioration according to the October 2013 and January 2014 NHDOT bridge inspection reports for the Northbound and Southbound bridges respectively. Partial-depth concrete repairs on the abutments and wingwalls from the 1984 rehabilitation exhibit cracking. Minor to moderate concrete spalls along the abutment backwalls were also noted, and

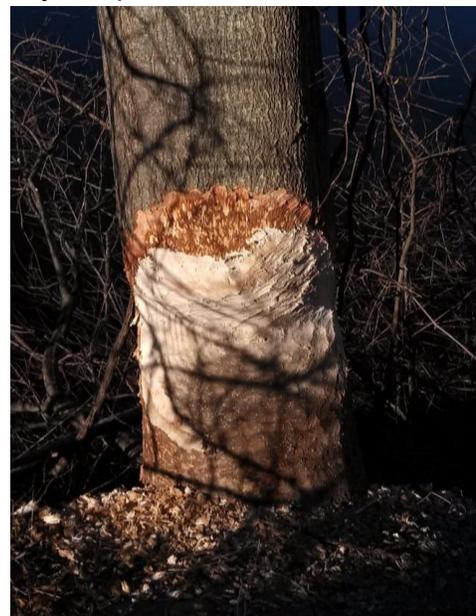
Figure ENV2: Beaver work, New Hampshire side, north of bridge.

vicinity of the bridge is mapped as “Tier 2, top-ranked in region.” Although the area surrounding Route 12 in Lebanon is developed and unlikely to provide valuable wildlife habitat, the area along the river is well vegetated and likely provides habitat for a variety of mammals, including deer, coyote, beaver, otter, raccoons, and other mammals (See Figure ENV2).

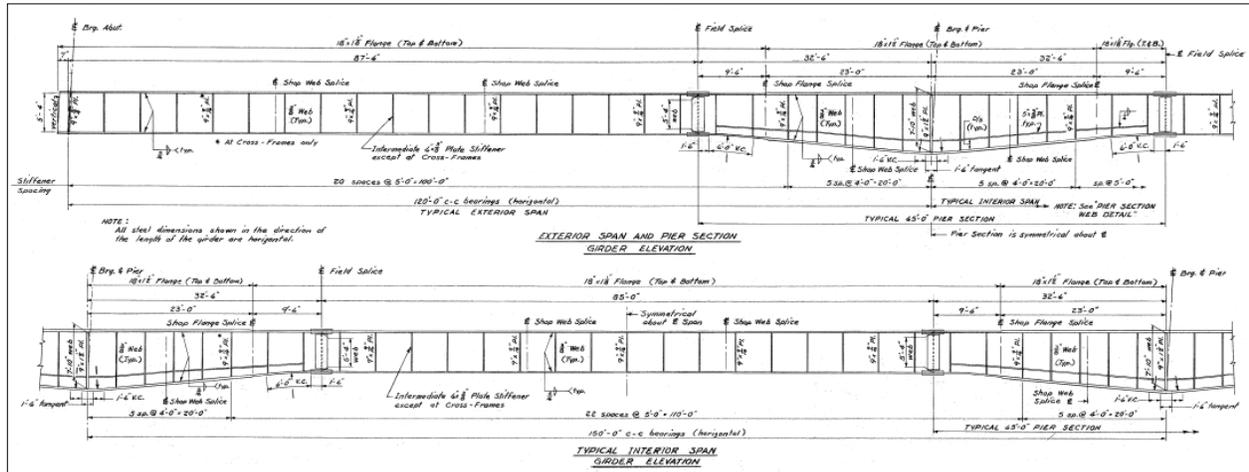
Figure LR1 – Girder Elevation Views from Original Design Plans

The existing bridges consist of five (5) continuous non-composite welded plate girders with a concrete deck. The girders are stiffened both transversely and longitudinally and have haunched webs near the intermediate piers. Detailed girder elevation views from the original construction drawings are shown below in Figure LR1.

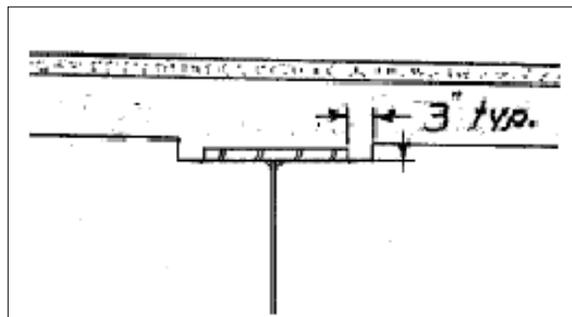
Figure LR2 –: Deck Haunch Detail

Per AASHTO MBE (Article 6A.6.9.3), the load rating considered the top flange of the girders to be continuously braced by the concrete deck in areas of positive flexure, despite a lack of shear connectors joining the girders and deck. The top flange lateral support mechanism for this bridge is twofold: friction between the deck and the top flange (provided there are no visible gaps), and the original plans show the top flange embedded in the deck haunch which provides additional lateral support. Refer to Figure LR2.
