**INTERIM INSPECTION REPORT
FOR THE
MEMORIAL BRIDGE
OVER THE PISCATAQUA RIVER**

August 2010

HDR

Part I: Interim Structural Inspection Report

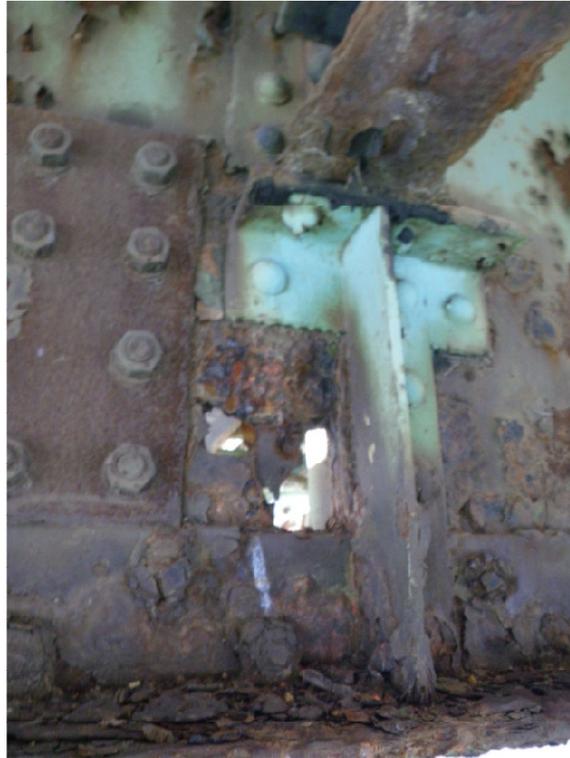
Photo 7: Span 1, Floorbeam FB4, North Face. Web at Stringer S5. Holes in web below stringer.
