US Route 2 (Rogers' Rangers) Bridge -Lancaster, NH – Guildhall, VT
NHDOT Bridge No. 111/129 – Project No. 16155
Inspection Photos

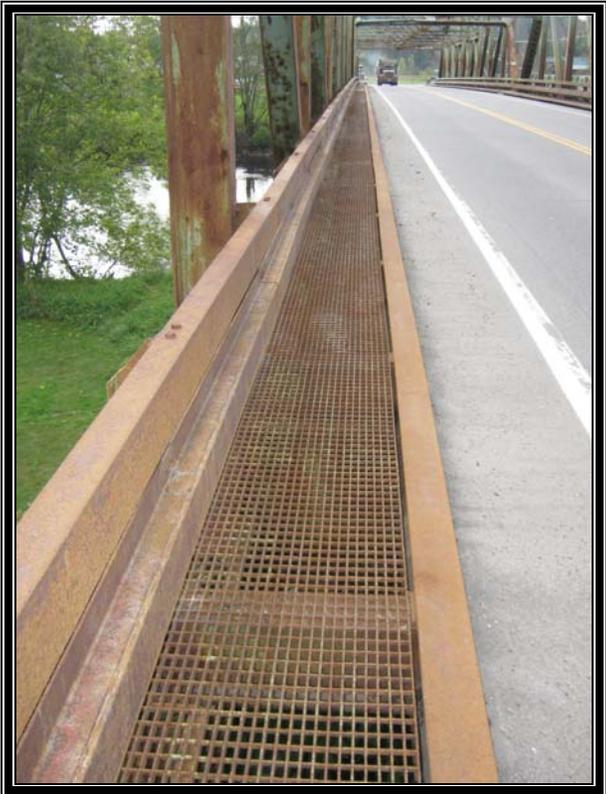
Photo 10: Open Grid Safety Curb

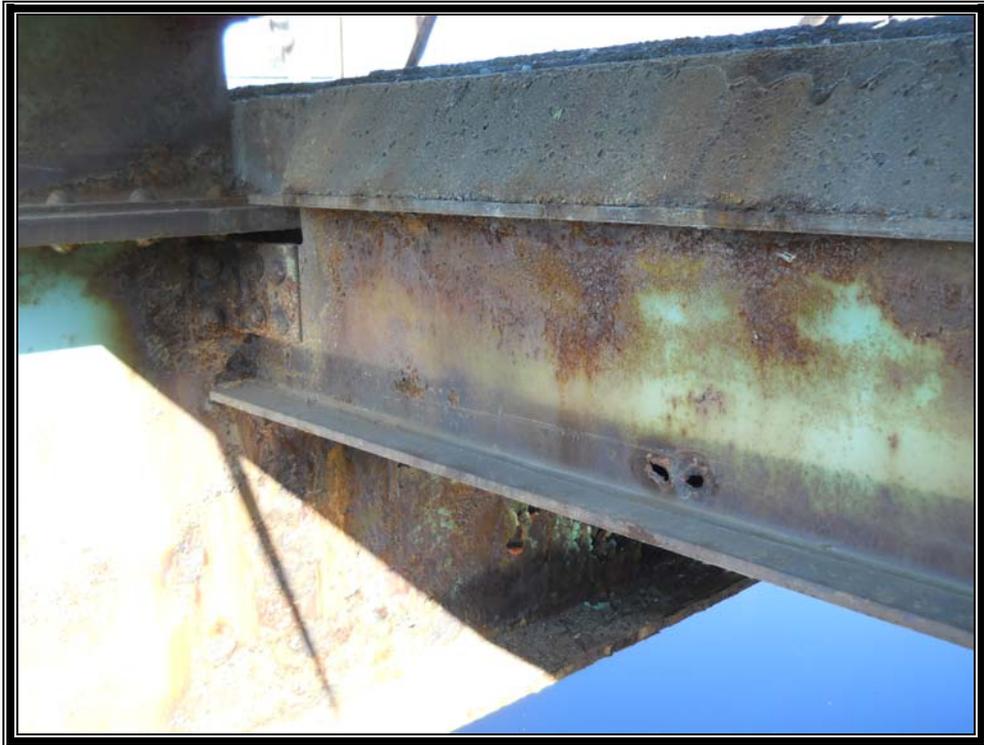
Photo 26: Span 1, Stringer 91 Web Holes

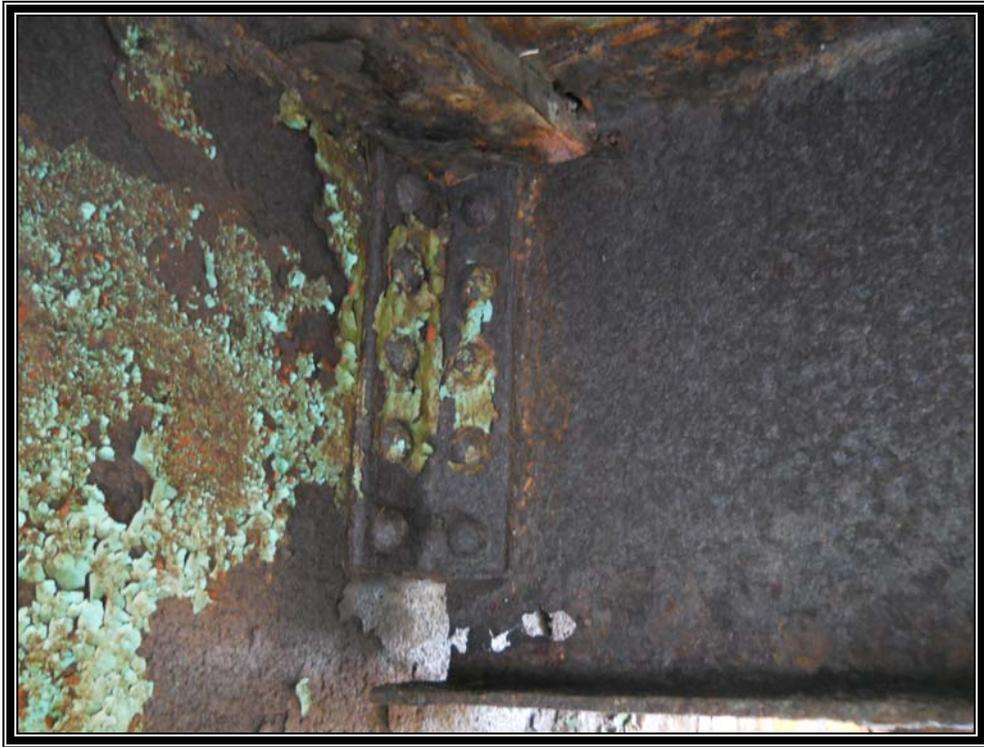
Photo 29: Span 1, Stringer 72 Holed Web

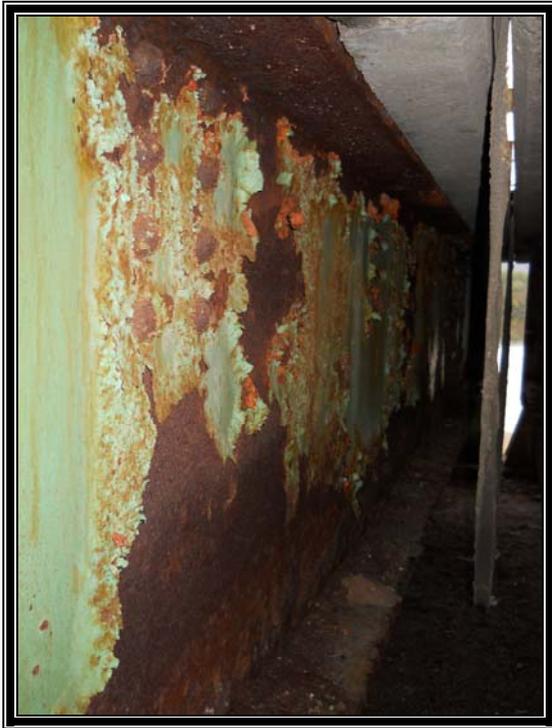
Photo 33: Span 2, Floorbeam FB0
(Also Shows Failed Compression Seal Hanging Below the Bridge Deck)

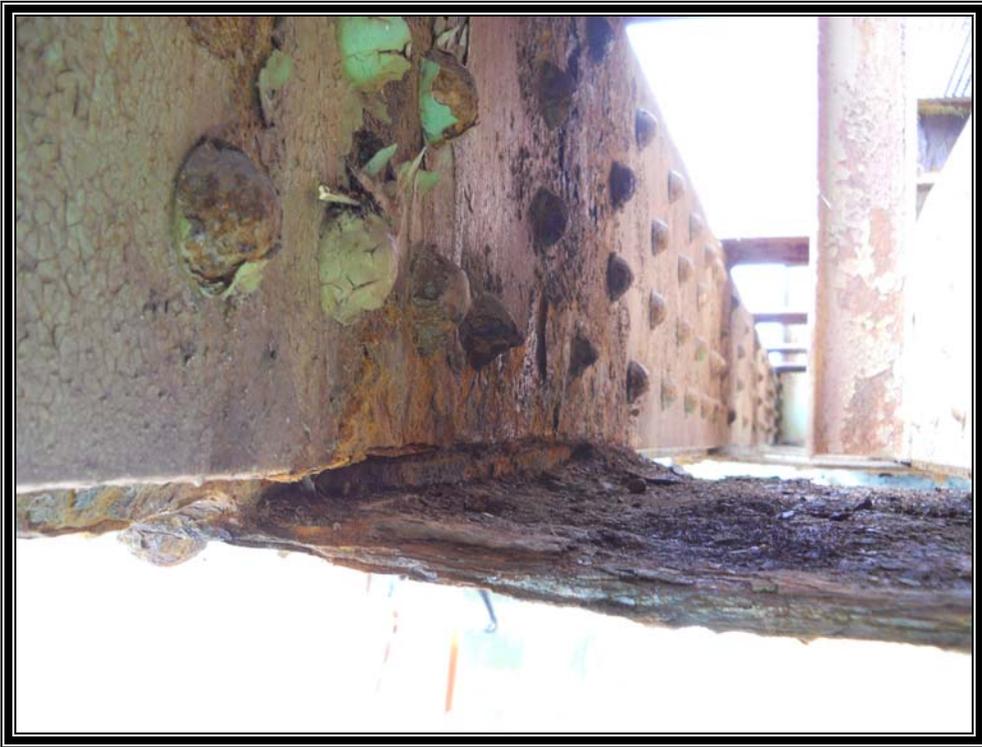
Photo 37: Typical Bottom Chord Interior Side Plate Height Loss

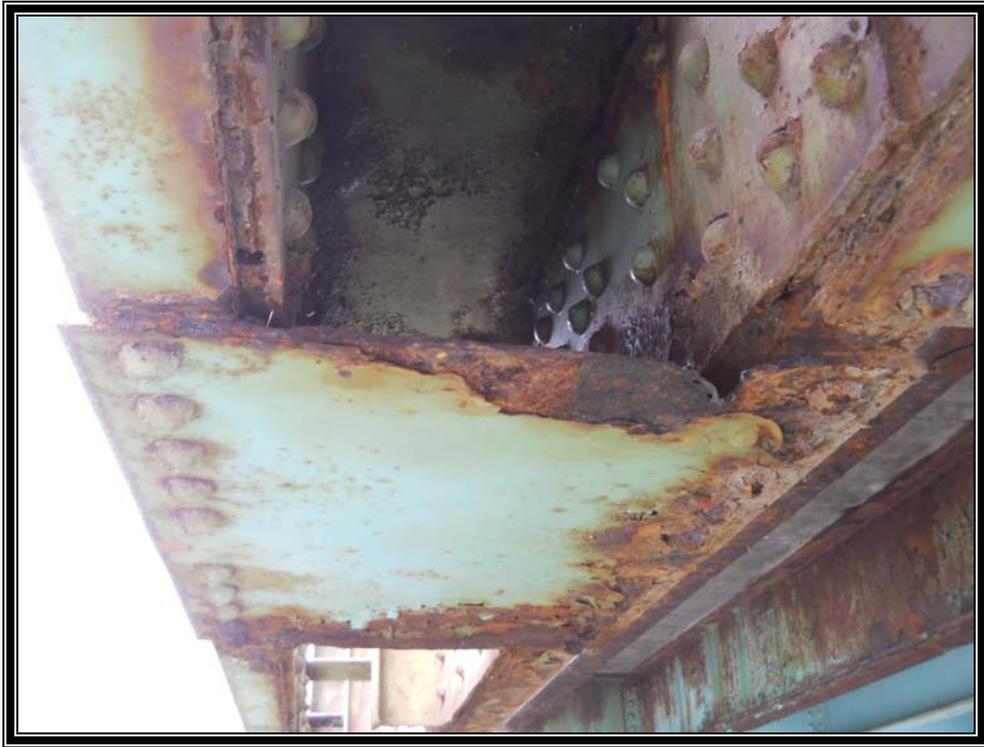
Photo 42: Span 1 South Truss Bottom Chord Member L3-L4 Flange Splice Plate Section Loss

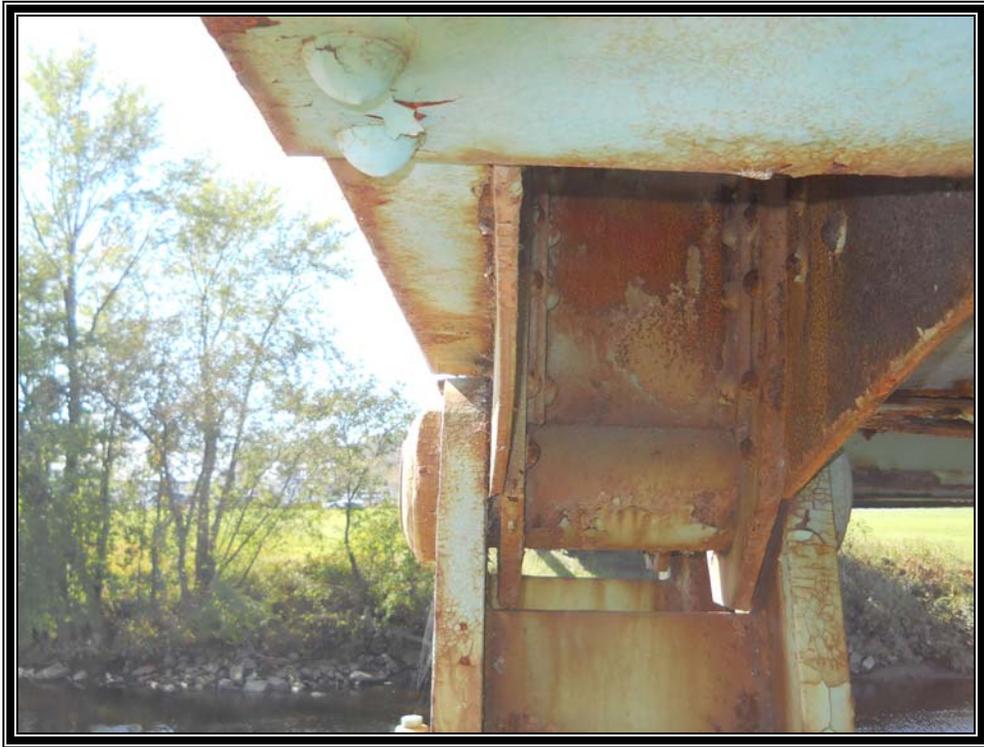
Photo 67: Span 2 South Truss Bent L0 Gusset Plate

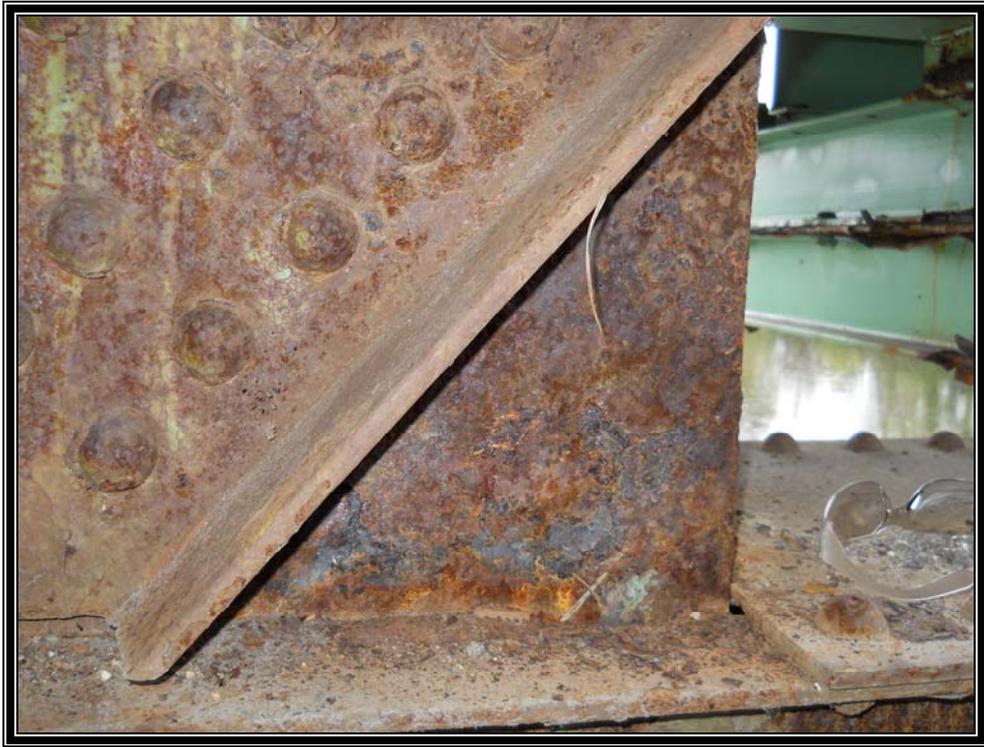
Photo 68: Span 2 North Truss L0 Gusset Plate with Section Loss

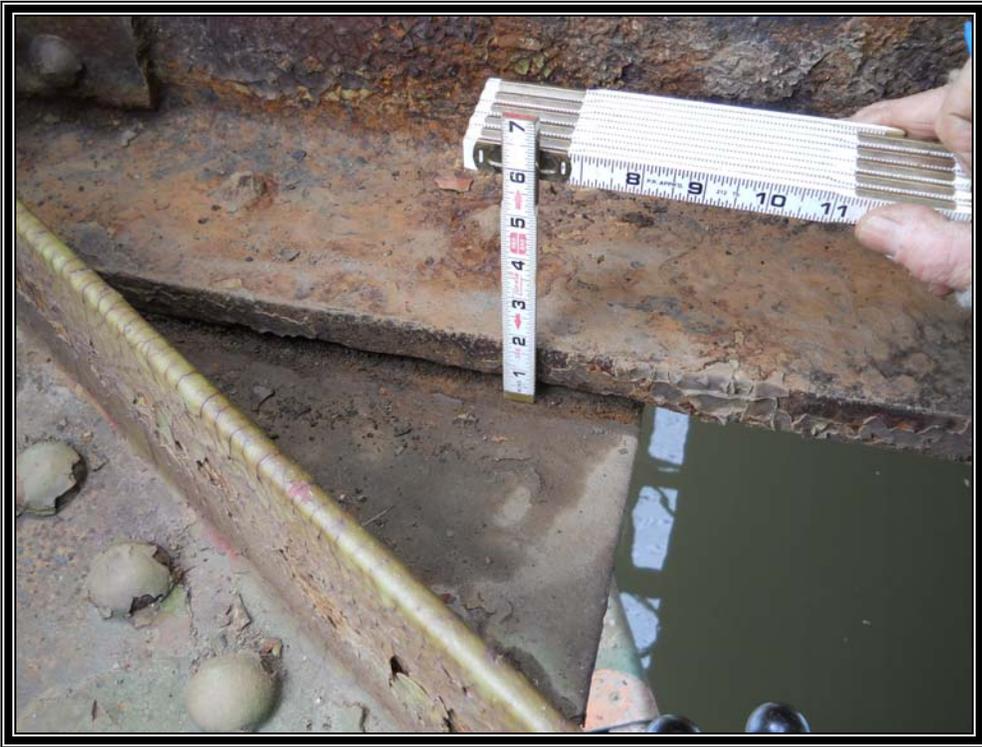
Photo 69: Typical Lower Lateral Bracing Gusset Plate Pitting

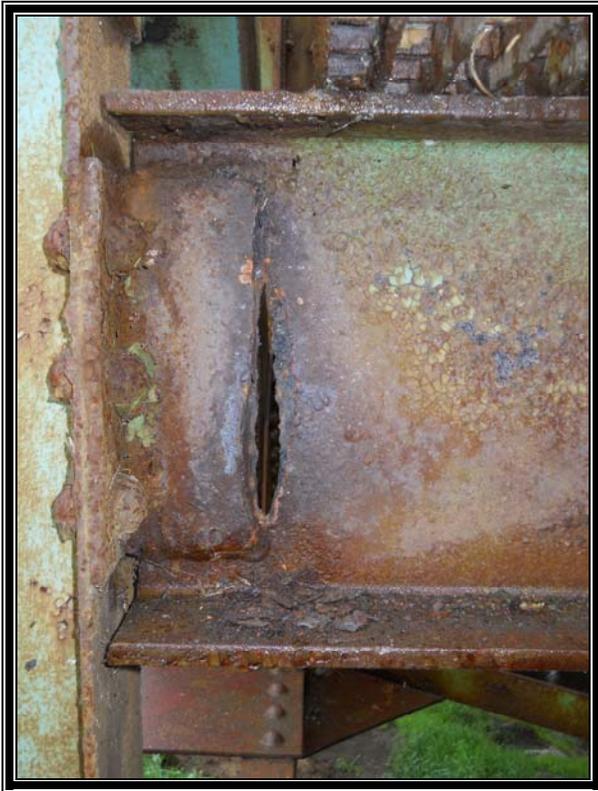
Photo 73: Typical Open Girder Safety Curb Supporting Member Typical Web Hole

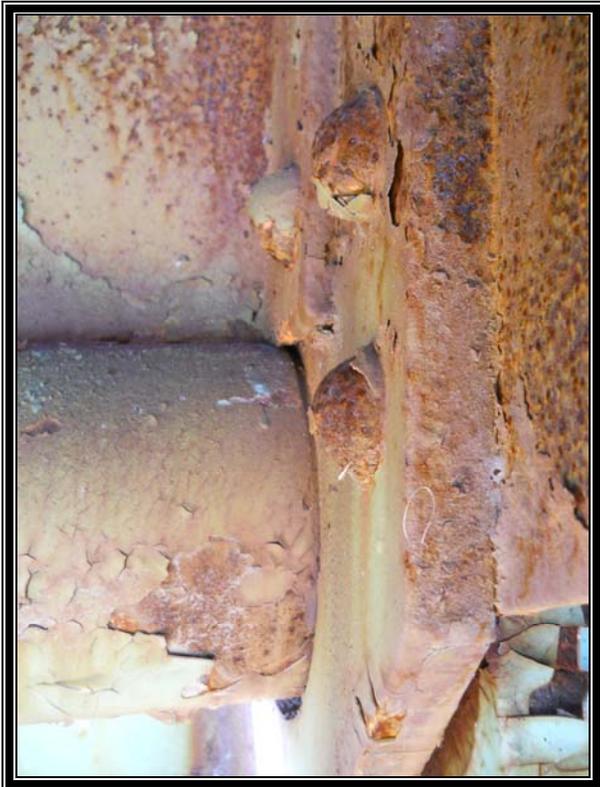
Photo 78: Span 2 South Truss Rocker Bearing Deformation (Shoulder)

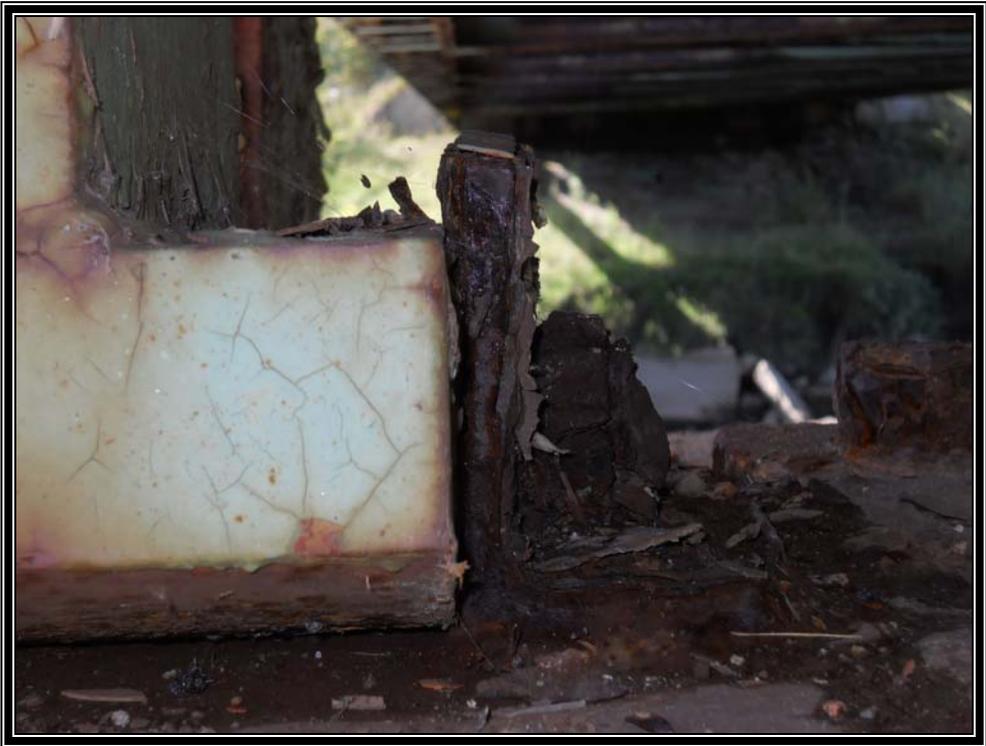
Photo 80: Span 2 South Truss Rocker Bearing Contact with Keeper Plate
